Research Paper

GEOTECHNICAL CHARACTERIZATION OF GEOLOGICAL FORMATION AT SLUMP SITES WITHIN SOUTH-WESTERN OUTSKIRTS OF ZUNGERU, NORTH CENTRAL NIGERIA

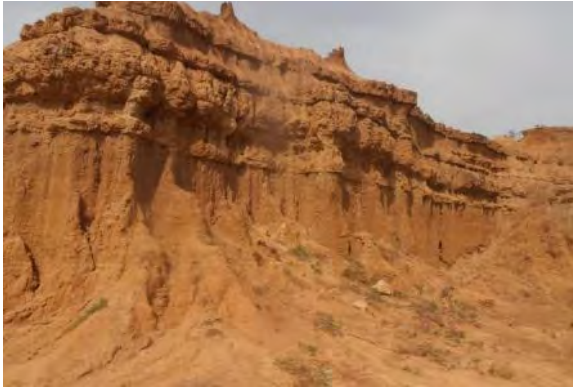
Figure 2: Slumping Site 1, Latitude N9° 46' 50'' Longitude E6° 8' 32''

Figures 2, 3, 4 and 5 are some slumping sites revealed during surface geological reconnaissance. Vegetation is being destroyed in the sites (apart from site 3), and the road linking neighbouring communities is gradually etching away. The reconnaissance also revealed amphibolite and schist outcrops intruded by granites. These basement rocks are overlain by thick massive to vaguely bedded sandstone that belongs to Doko member of Bida Formation. The Doko member is the slumping lithostratigraphic unit. It consists of clay matrix conglomerates at its base, and a vaguely bedded fining upward sequence of medium-fine sand, siltstone and mudstone.

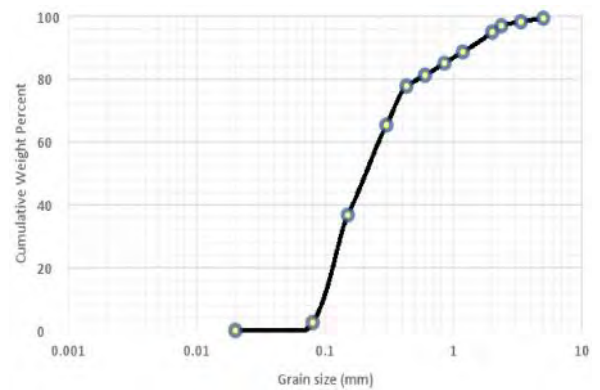
Figure 6: Plot of Mass Passing (PMP) versus Sieve Grain Size (Slump Site 1)

Table 3 is the sieve analysis result for slump site 1. Figure 6 is the plot of Percentage Mass Passing (PMP) versus sieve grain size for samples from slump site 1. Figure 7 is a bar representation of grain sizes in samples slump site1. The graph shows that the formation is mostly fine sand, with subordinate medium to coarse sand, fine gravel and coarse silt. Values of C_u and C_c are 2.85 and 0.764 respectively.

This indicates that the geological formation is poorly graded at this slump site. Table 4 is the sieve analysis result for slump site 2.

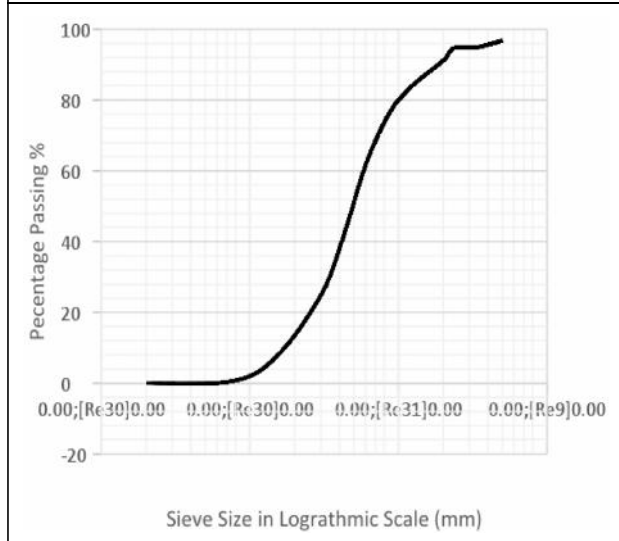
Figure 8: Plot of Percentage Mass Passing (PMP) versus Sieve Size (Slump Site 2)

Figure 8 is the plot of Percentage Mass Passing (PMP) versus sieve grain size for samples from slump site 2. Figure 9 is a bar

chart representation of the particle sizes. The graphs revealed that the sample consists mainly of medium to coarse sand with some

fine sand, coarse silt and fine gravel. Estimated values of C_u and C_c are 0.57 and 0.148 respectively, which indicates it is poorly graded. Table 5 is the sieve analysis result for slump site 3.

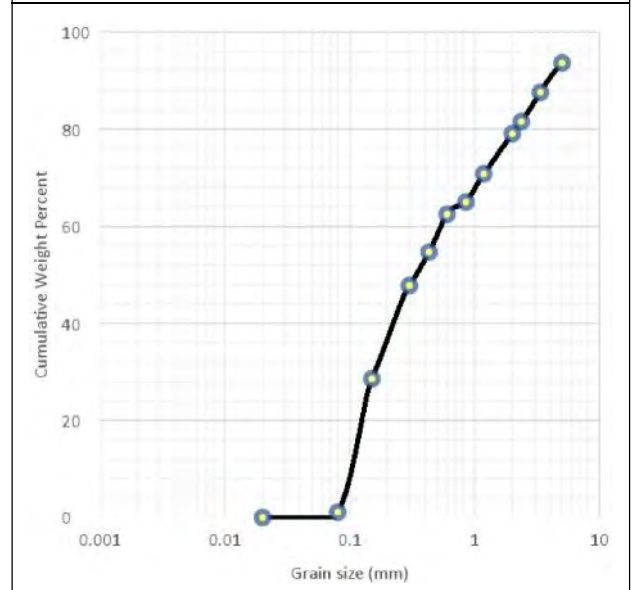
Figure 10: Plot of Percentage Mass Passing (PMP) versus Sieve Grain Size (Slump Site 3)

Figure 10 is the plot of Percentage Mass Passing (PMP) versus sieve grain size for samples from slump site 3. Figure 11 is its bar chart representation. The graphs revealed that

the sample contains high amounts of fine sand, medium to coarse sand and fine gravel. Estimated values of C_u and C_c are 5.31 and 0.711 respectively. The C_u reflects substantial amount of gravel, and is fairly graded.

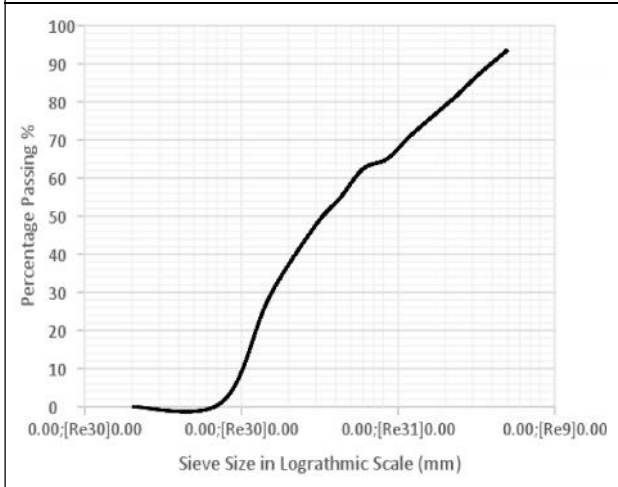
Figure 12 : Plot of Percentage Mass Passing (PMP) versus Siev Grain Size (Slump Site 4)

The sieve analysis results for sample from slump site 4 is Table 6. Its plot of percentage mass passing (PMP) versus sieve grain size is Figure 12. The bar chart representation of its

particle grain size is Figure 13. The graphs reveal very high amount of fine sand and considerable significant coarse silt. Proportion of medium to

coarse sand and fine gravel is high as well. Its C_u and C_c are 1.280 and 0.10 respectively, which indicates poor grading.

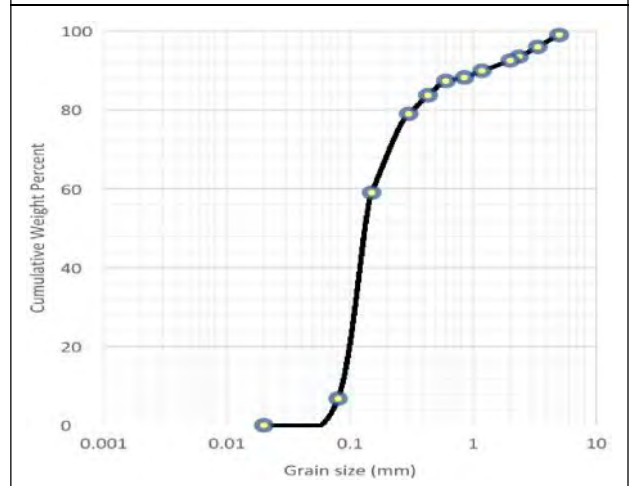
Figure 16: Plot of Percentage Mass Passing (PMP) versus Sieve Grain Size (Slump Site 6)

Table 8 is sieve analysis results for sample from slump site 6. Figure 16 is the plot of Percentage Mass Passing (PMP) versus sieve grain size for samples from slump site 6. The histogram representation of the grain components is Figure 17. The sample comprises fine sand, medium grained sand, coarse sand and fine gravel. C_U and C_C for samples from site 6 are 1.87 and 0.912 respectively, and these indicate poor particle size grading.
