Stability Assessment and Design of Open Pit Slopes of Limestone Mines in India

Sandi Kumar Reddy

Mining Engineering Department, National Institute of Technology Karnataka, Surathkal, Karnataka, India

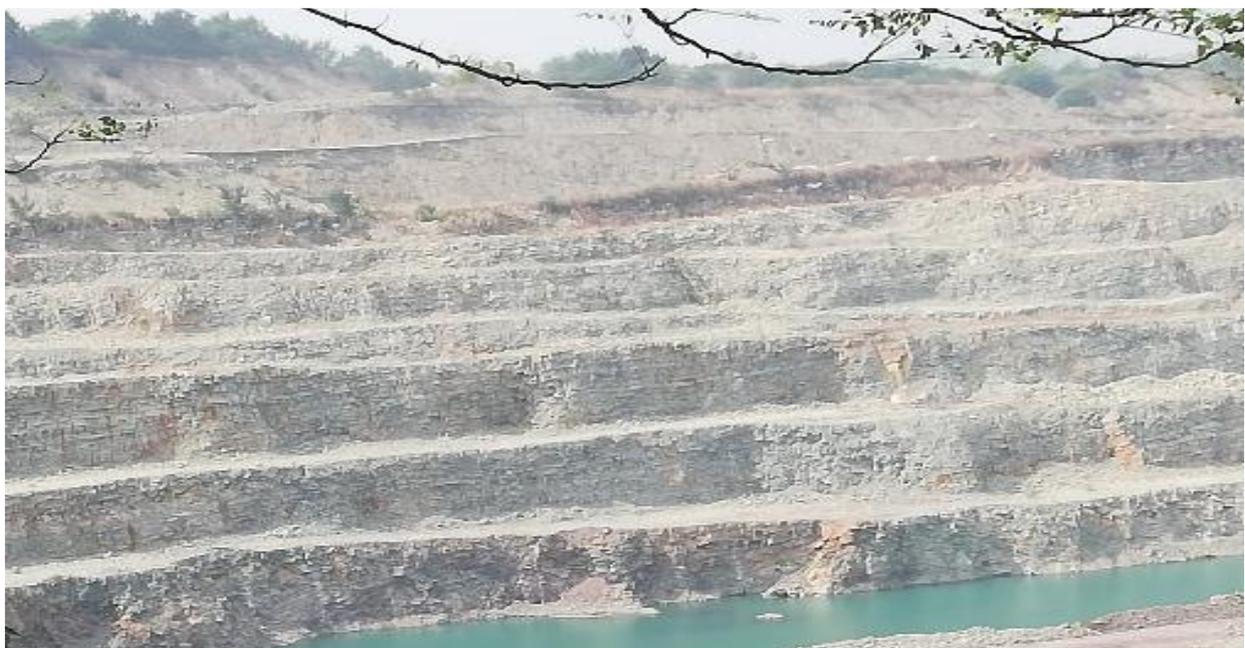
Figure 1. A view of the open pit limestone mine [28].

The limestone mine is working at a maximum depth of 90m and consists of eight benches with an inclination of about 70 degrees (Fig. 1). The mine consists of an active dump at the crest of the pit slope with a maximum height of 65m. Detailed exploration in the mine lease area revealed the presence of limestone ore reserves up to 110m depth. Deeper excavations become especially important as open pit mines reach greater depths due to land availability limits. The deposit is faced with numerous geological discontinuities (i.e., joints and faults). The slopes in the excavation are non-homogenous. The slope stability state in a limestone mine is typically governed by several factors such as rock/soil formation thickness, rock mass condition, the existence of major and minor faults, rainwater infiltration into the slope, and the existence of external loads on cut slopes.

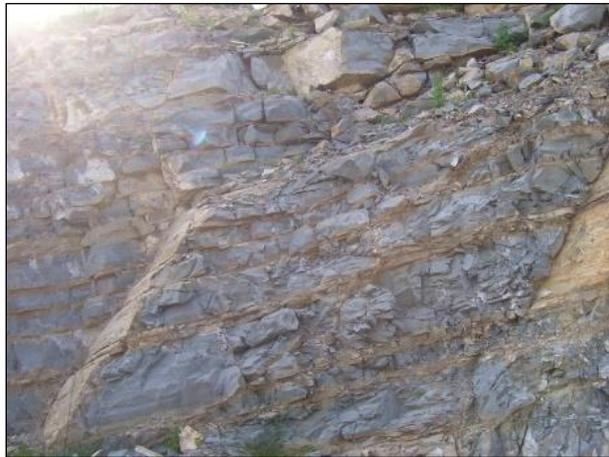
Figure 2. Two sets of joints in the benches of the mine [28].

close-spaced vertical joints, and gentle to highly folded structures (Figs 2–3). The geological sectional view of the open cut slope is given in Fig. 4.

Detailed joint mapping was carried out in different sections of the mine. Two distinct sets of joints were identified in the mine, mostly vertical joints trending E-W and N-S. A summary of the joint features observed in the mine is given in Table 1. The joints are close-spaced at 5 to 10cm. They are mostly tight, but occasionally ferruginous/calcareous and clayey material filling was also present. The joints are smooth with planar discontinuities. The rocks are dry, and no water seepage was observed anywhere within the mine. Minor (small-sized) limestone cavities are present in some places.

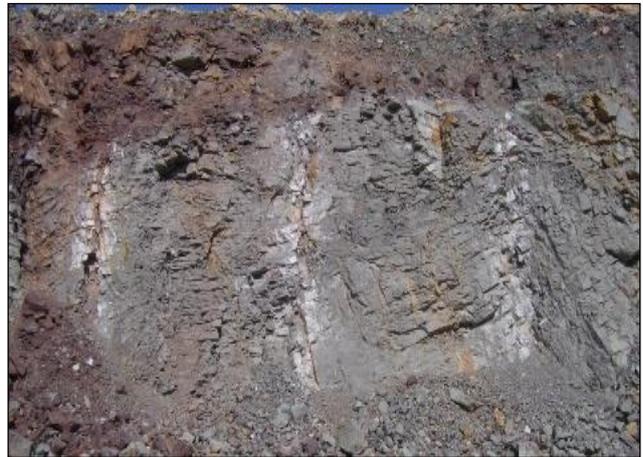
Figure 3. Joint filled with ferruginous material in the benches [28].

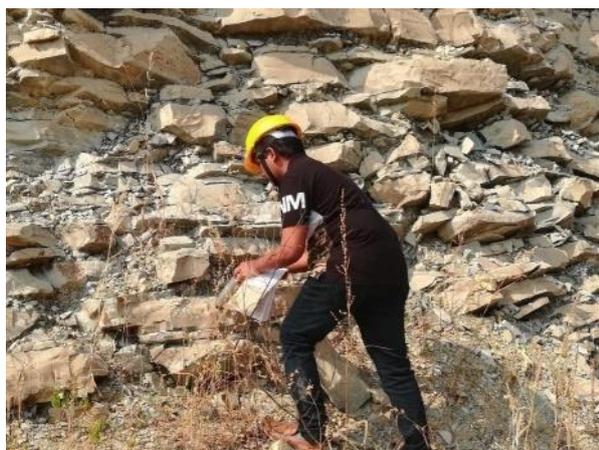
Figure 5. Field mapping in the mine.

Kinematic analysis was used to show the potential for different modes of rock/soil slope failures (i.e., planar, wedge, and toppling failures) caused by the presence of unfavourably oriented discontinuities [28]. The analysis was based on Hoek and Bray's description of Markland's test. Kinematic analysis was performed with rock material friction angle, discontinuities measured, and orientation of slopes to identify any possible structurally controlled failure at the investigational locations. The kinematic analysis of the slopes shows that structurally controlled collapse will not occur on these pit slopes. The results of the field mapping (Fig. 5) and core logging were tabulated in Table I.

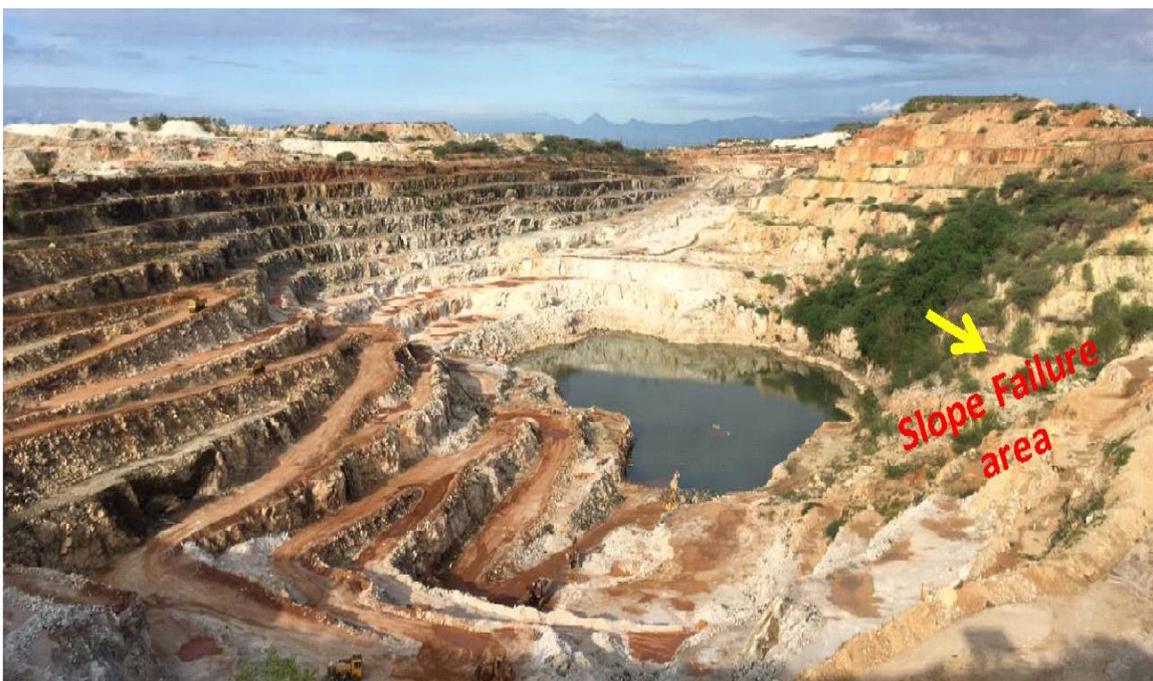
Figure 11. A photograph showing slope failure area in the limestone mine [29].

leaving nine benches each 10m in height with a final slope angle of 27° (Fig. 11). On both sides of the limestone mines lease area, i.e., East and West sides, the other limestone mines are in operation. The waste from limestone mines is dumped on both the South and North side of the lease area. For limestone extraction and overburden removal, drilling and blasting, shovel-dumper machine combinations are used.

There is a slope failure and tensile cracks were discovered towards the north side of the pit which is a concern regarding the stability of the slopes in the mine. So, geotechnical investigations were conducted to determine the possible causes of failure on the north side of the limestone mine.

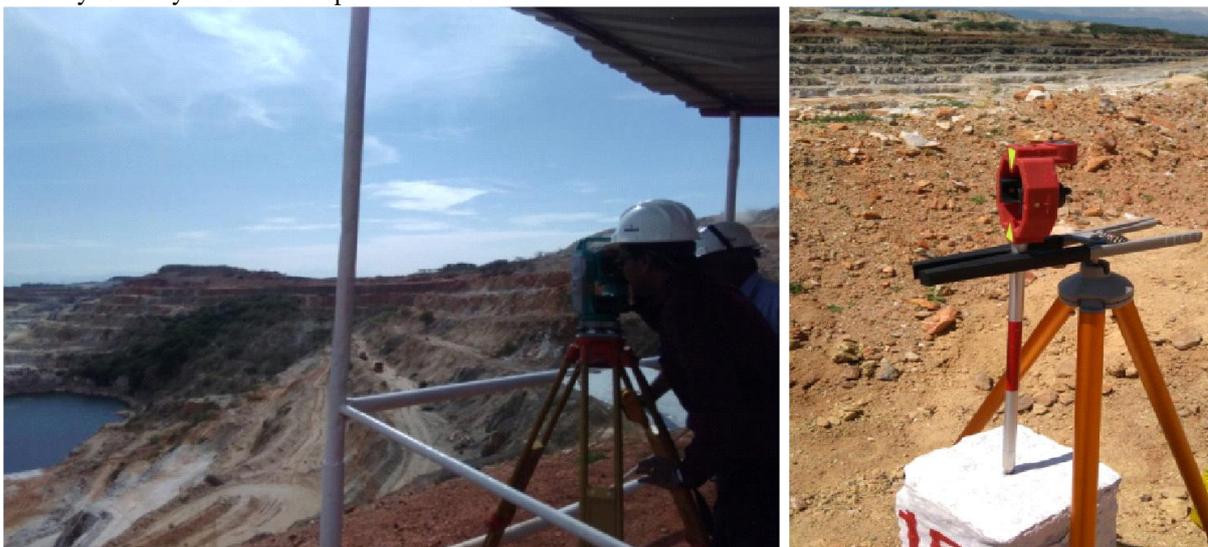
Figure 13. Prism network and monitoring setup in the limestone mine [29]

In total 36 points were identified as critical locations towards the North side of the pit. The monitoring was carried out after failure on the North wall for a period of one year on a daily basis (Fig. 13). A maximum of 150mm deformations recorded in the prism stations within 5m of the failure zone on the North wall have occurred within 7 days of failure and later strata is stabilized and no deformation was observed in the prism stations outside the 5m to failure zone. Therefore, it indicates that within 5m of the failure zone stabilized within seven days of the failure, and strata outside the 5m from the failure area is not influenced by failure which is in stable condition.
